Fire Assessment Report for Blisswood Global Impex Pvt. Ltd.

June 24, 2024

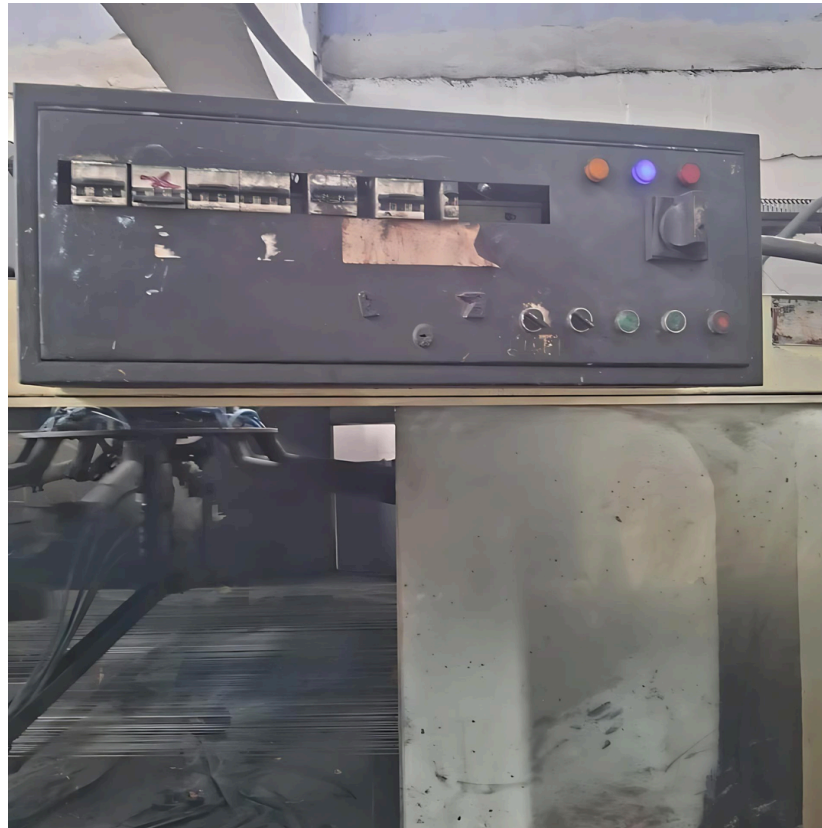
4. High-Risk Autospray Machines

Issue: Autospray machines have been retrofitted and operate manually, creating significant fire hazards:

- Fans intended to maintain temperature are manually controlled.
- Inadequate response to power cuts and post-heater cooling.

Risk Level: Critical

Impact: Manual operation increases the likelihood of overheating, leading to fire outbreaks, especially in leather manufacturing.

Relevant IS Code: IS 1646:1997

Image 1 : Aged Electrical System in Auto Sprayer

4. Automate Autospray Machine Operations:

- Retrofit machines with automated controls for fans and heaters to ensure they operate safely under all conditions, including power outages and postoperative cooling. Auto shutoff if critical temperature thresholds are reached, this ensures that multiple checks and systems are in place to stop any incident from happening and report an incident as quickly as possible in case of any emergency.

Relevant IS Code: IS 1646:1997

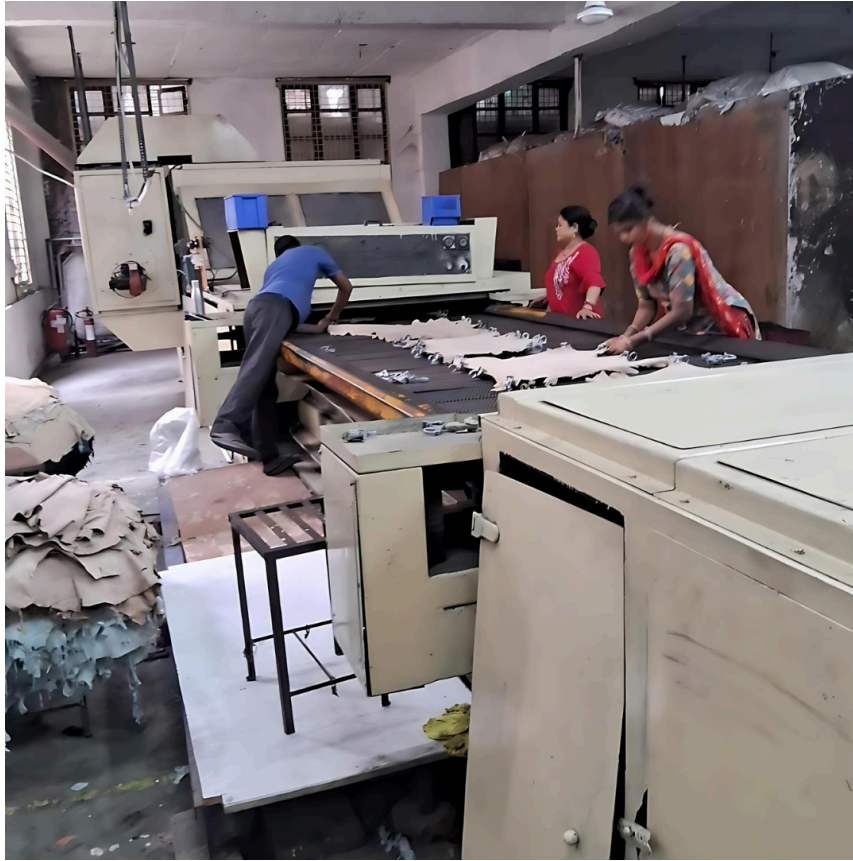
5. Toggling Machine with Heater in Basement

Issue: The toggling machine with a heater is located in the basement amidst a large stockpile of leather.

Risk Level: Critical

Impact: The combination of heat and flammable materials elevates the fire risk dramatically.

Relevant IS Code: IS 1641:1988

Image 2: The toggling machine with heater in close proximity to stored leather

5. Relocate or Upgrade Toggling Machine Setup:

- Move the machine away from the leather stockpile or enhance fire safety measures in the basement, including improved ventilation and fire barriers. Toggling machine also needs to be set up with automated temperature controls and an IOT based reporting system that ensures safety in case of emergency.

Relevant IS Code: IS 1641:1988

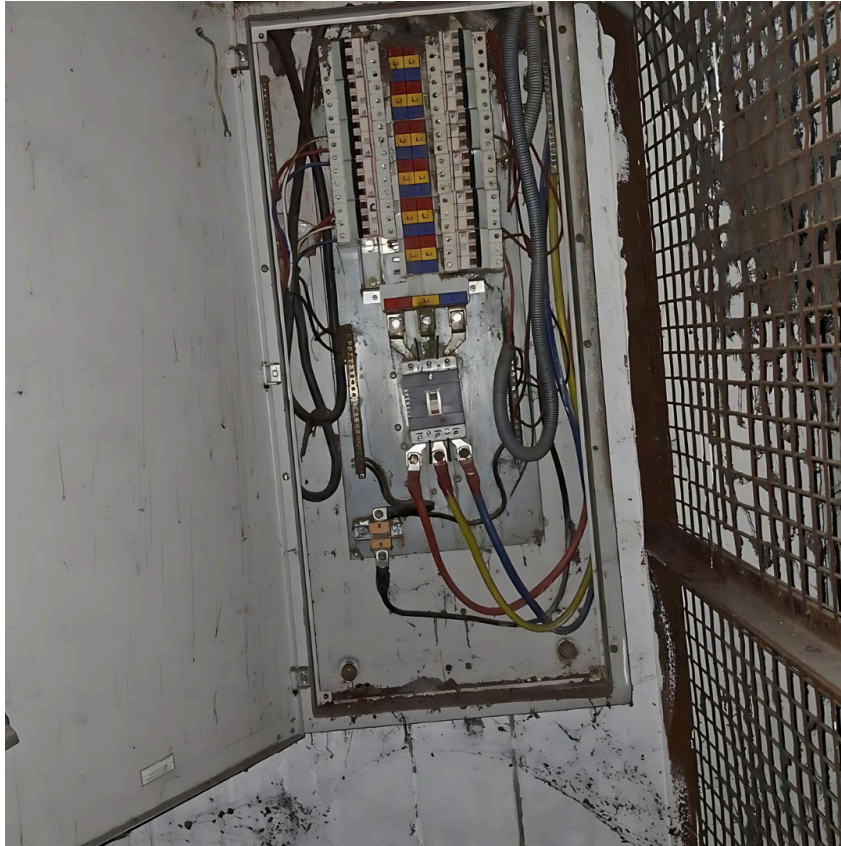
6. Exposed Electrical Panels

Issue: Exposed electrical panels are located next to stored leather.

Risk Level: Critical

Impact: Electrical sparks or faults could ignite the leather, causing rapid fire spread.

Relevant IS Code: IS 1646:1997

Image 3: Exposed electrical panels right in the middle of leather storage

6. Secure Electrical Panels:

- Encase electrical panels in fire-resistant enclosures and maintain a safe distance from flammable materials. The sections inside the basement should also be isolated with fire retardant materials like intumescent paints to ensure that in case of a fire event the fire does not spread unchecked.

Relevant IS Code: IS 1646:1997

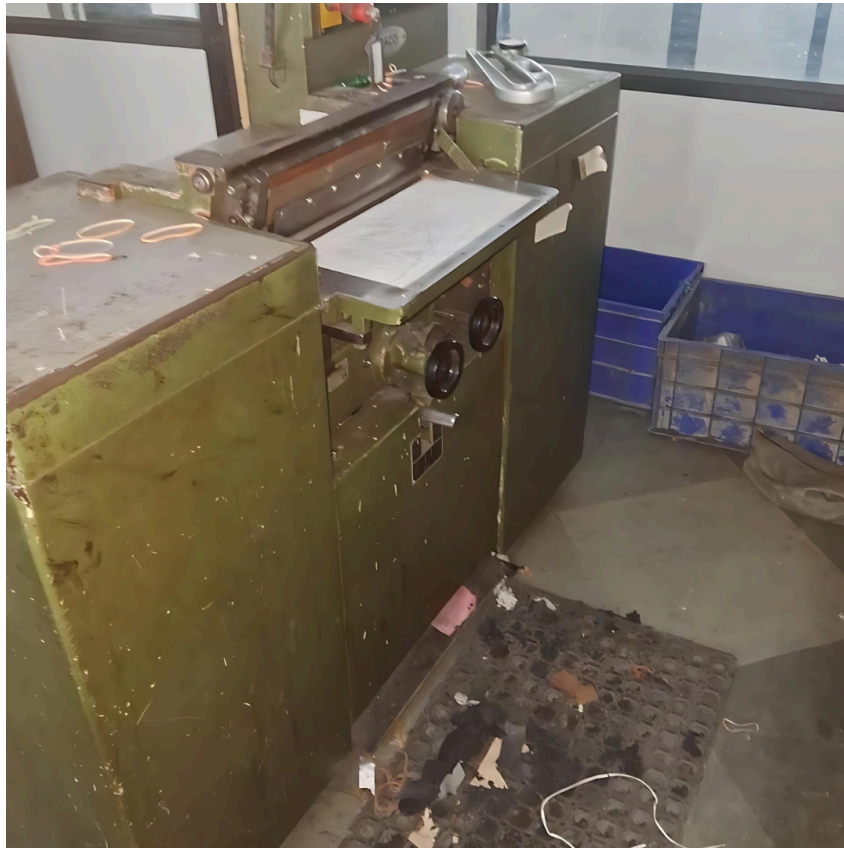
8. Skiving Machine Sparks

Issue: The skiving machine generates sparks during tool sharpening.

Risk Level: High

Impact: Sparks can easily ignite flammable materials, especially in a leather manufacturing environment.

Relevant IS Code: IS 3034:1993

Image 4: Skiving Machine

8. Spark Containment for Skiving Machine:

- Implement spark arrestors and improve local exhaust ventilation to reduce fire risks from the skiving machine.

- The scrap generated from this machine should also be collected in a separate bin with fire retardant materials.

Relevant IS Code: IS 3034:1993
